Manhole Inspection Summary

Manhole # S09SS_014MH

Insp Date: **8/16/07 1:11 PM**

Location Address: **3411 DUVALL AVE**

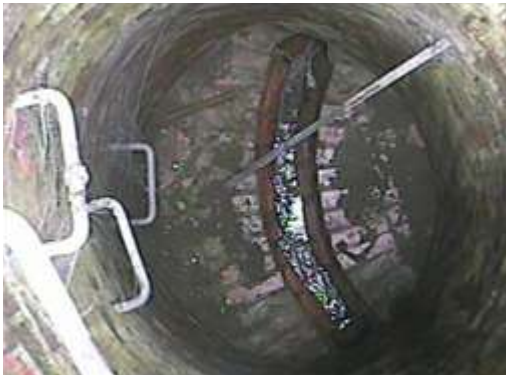
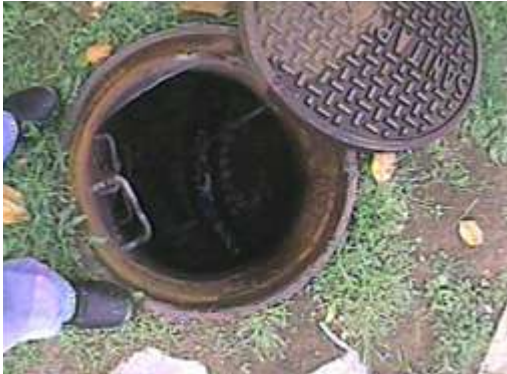
Top View

Type: **Sanitary** Condition: **Sound** Cover Material: **Cast Iron**

Frame Offset: **0** (in.) Condition: ☒ Sound ☐ Cracked ☐ Leaks

Condition: ☒ Sound ☐ Cracked ☐ Root Intrusion ☐ Loose Brick ☐ Deteriorated

Condition: ☒ Sound ☐ Cracked ☐ Root Intrusion ☐ Deteriorated ☐ Leaks ☐ Debris

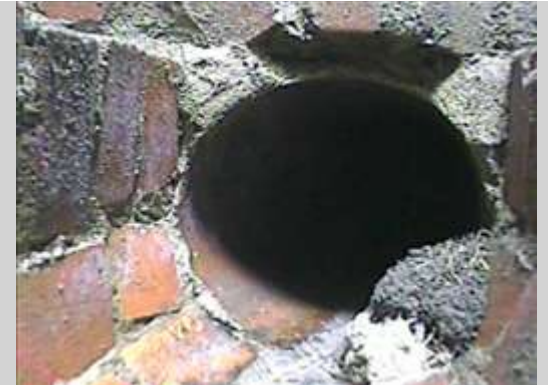
12 O'Clock Outflow

8 in. Circular Gravity Sewer
Pipe Out @ 12 O'Clock

Pipe Material: **Clay** ☐ Pipe Lined

Invert Depth: **7.52** (ft.) Flow Characteristics: **Slow**

Deposits: ☒ None ☐ Mud ☐ Sludge ☐ Debris ☐ Grease

Infiltration: **None** Pipe Seal Cond: **Sound**

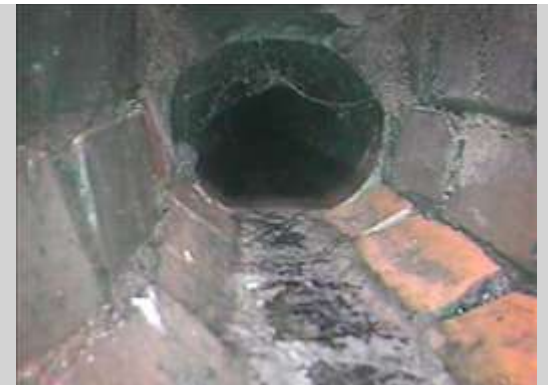
4 O'Clock Inflow

6 in. Circular Gravity Sewer
Pipe In @ 4 O'Clock

Pipe Material: **Clay** ☐ Pipe Lined

Invert Depth: **7.36** (ft.) Flow Characteristics: **Slow**

Deposits: ☒ None ☐ Mud ☐ Sludge ☐ Debris ☐ Grease

Infiltration: **None** Pipe Seal Cond: **Sound**

Connects To: **House connection / Service line**
